Paper No. 04077

COOLING WATER MONITORING USING COUPLED MULTIELECTRODE ARRAY SENSORS AND OTHER ON-LINE TOOLS

Michael H. Dorsey DuPont Engineering Technology Orange, Texas 77630, USA

Lietai Yang and Narasi Sridhar Southwest Research Institute San Antonio, TX 78238–5166, USA

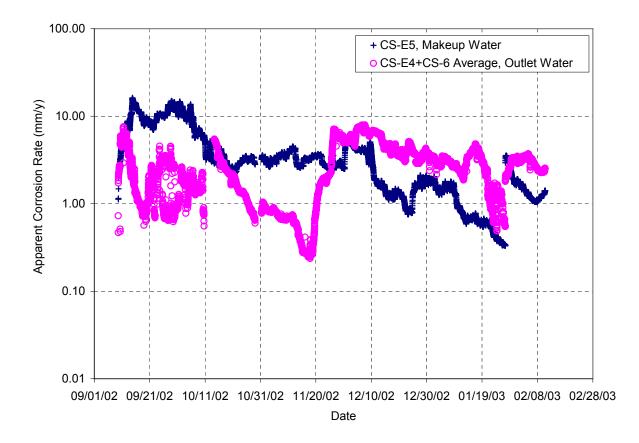
The initial corrosion penetration rate in the makeup water was exceptionally high at approximately 12 mm/year or 472 mil/year at the beginning of the measurements. The signal decreased two weeks later and stabilized at approximately 1.2 mm/year or 47 mil/year near the end of the measurements. The exceptionally high penetration rate observed during the start of the measurements may be attributed to the fresh surface of the electrodes. Once the electrode corroded, the rate decreased because the corrosion product formed a diffusion layer on the metal and limited the corrosion rate. A general trend for the corrosion rate observed in the makeup water was that the rate was high during the start (not accounting for the data in the first three weeks) and lower at the end of the measurements. This trend is could be due to the temperature change in the ponds that were warm in the fall and colder in the winter (Figure 3) because this water was not heated or cooled before reaching the test station. There were several sudden increases and decreases in the corrosion signals from the probe, some of which may be attributed to sudden flow changes. A sudden restart of the flow after a few days shut down may cause spalling of the corrosion products on the surface of the sensor and result in a higher shortterm corrosion rate. The average penetration rate which corresponds to the rate at the most active pitting area of a coupon over the 5.5-month monitoring period was 3.78 mm/year (149 mil/year).

Unlike the case in the makeup loop, the trend of the corrosion rate in the outlet water is not so consistent because the temperature was less affected by the weather and there were more changes in the variables that might affect corrosion. These variables include corrosion inhibitor, pH, conductivity and dissolved oxygen. Because of the changes in many process variables, the measured corrosion rate which corresponds to the rate at the most active pitting area of a test coupon in the Outlet water system fluctuated between 0.2 to 7.5 mm/year (7.87 to 295 mil/year). The increase in sensor CS-E4's signal on 10/14/02 was due to a flow surge when the valve to the loop was re-opened. The average penetration rate for the most active pitting area over the 5.5-month monitoring period in the outlet water was 2.67 mm/year (105 mil/year).

Figure 5: Apparent localized corrosion penetration rates based on maximum anodic current densities from the different electrodes of the sensors in the two loops.

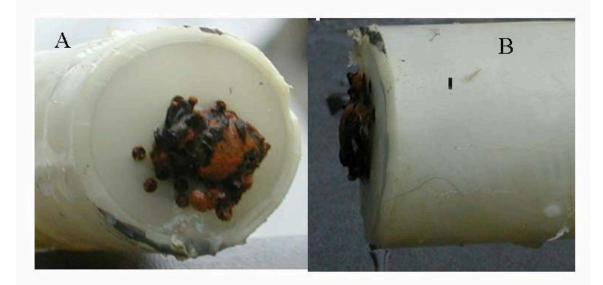
Figure 7 shows that patches of thick and loose deposits were typically formed on the sensing surfaces of the sensors after in the cooling water system for 5.5 months. Figure 8 shows typical post-service appearance of the sensing electrodes after removal of the deposits. Some of the electrodes were severely corroded and others were less corroded. During the measurements, the severely corroded electrodes acted as the anodes and the less corroded electrodes acted as the cathodes. The depth of attack of the most corroded electrode (measured after removal of the deposits) was 34 mil for sensor CS-E4 and 54 mil for sensor CS-E6. Sensor CS-E4 was in service for 5.5 months and sensor CS-E6 was in service for 3 months. The converted yearly penetration rates are 1.88 mm/year (74 mil/year) for the most active electrode in sensor CS-E4 and 5.48 mm/year (216 mil/year) for the most active electrode in sensor CS-E6. The average penetration rate from the two sensors is 3.68 mm/year (145 mil/year) which is surprisingly close to the measured average rate as shown in Figure 5 for the outlet water (3.78 mm/year or 149 mil/year).

Figure 7: Typical appearance of deposits formed on the surface of the sensors after 5.5-months in the cooling water system. Note: A-front view; B- side view; the deposits was approximately 5 mm thick.

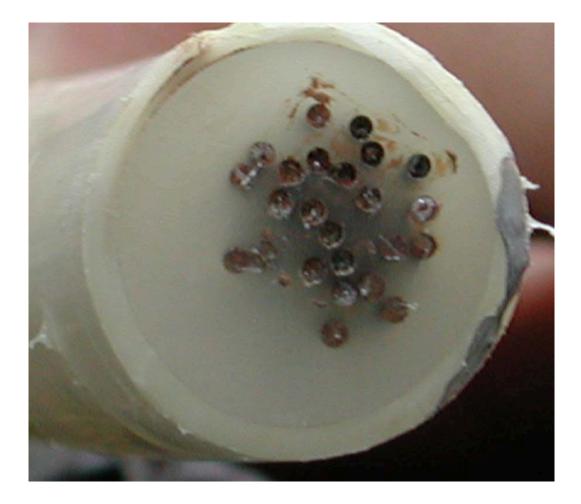
Figure 8: Typical post-service appearance of the sensing surface after the removal of the loose deposits. Some sensing electrodes were severely corroded

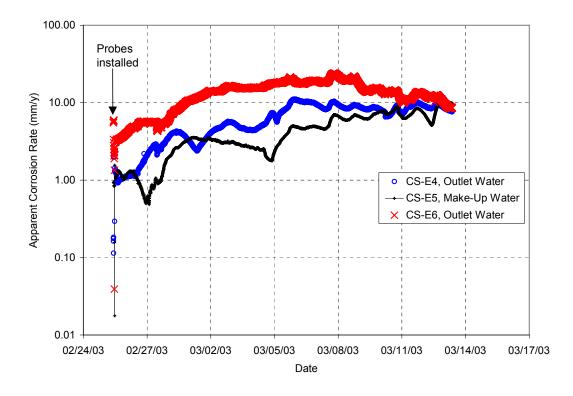
The sensors were re-installed in their previous locations after the sensing electrodes were examined and cleaned with 200-grit paper. Figure 9 shows the measured localized corrosion penetration rates that were derived from the most anodic current densities of the three sensors for another 16-day period. Similar to the signal from the makeup water as shown in Figure 5, all the signals increased following the start of the measurements and reached their maximum values in about 10 days. (All signals seemed to be on the decrease trend near the end of the test two weeks after the start). Figure 9 also shows that the two sensors (CS-E4 and CS-E6) fluctuated similarly, indicating that the fluctuations were due to the effect of the process parameters such as temperature, pH, flow rate or inhibitor concentrations. The localized corrosion signal from the sensor in the makeup water seems to be lower than those from the sensors in the outlet water system. This may be due to the fact that the outlet water temperature was higher than that of the makeup water during this period.

Figure 9: Apparent localize corrosion pennetration rates from the three sensors installed in the cooling water system during a shot-term

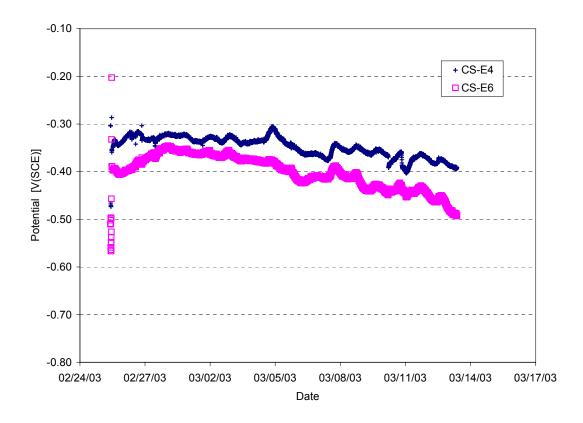
Figure 10 shows the potentials measured from the coupling joints of the two sensors in the return water system. The potential of the CS-E4 sensor was higher than that of the CS-E6 sensor, indicating CS-E6 was undergoing more localized corrosion. This is in agreement with the measured localized corrosion rates as shown in Figure 9. Figure 10 also shows a decreasing trend for the sensor potentials during the measurement period, indicating an increase in localized corrosion signals. This is indeed in agreement with the measured results shown in Figure 9.

Figure 10: Electrochemcial potentials of the two carbon steel probes in the outlet water loop during the measurements shown in Figure 9.

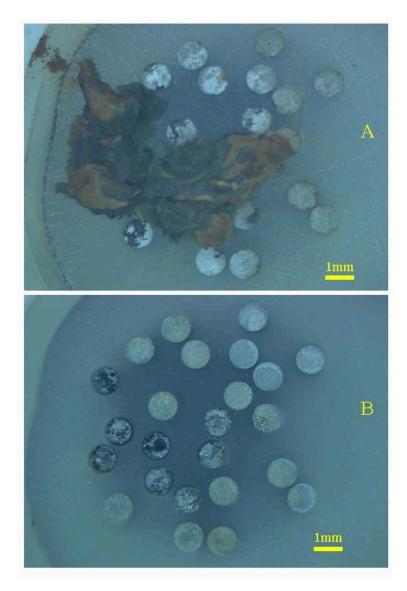
Figure 11 shows typical post-test appearances of the sensor before and after removing the loose deposits. The electrodes under the deposits were severely corroded and the electrodes not covered by the deposits were not corroded after the 16-day exposure in the cooling water system. This large difference in degree of attack is typical of microbiologically influenced corrosion⁴. The corroded electrodes were likely the anodes and the unattacked electrodes were more likely the cathodes. Figure 12, which shows typical currents from each electrode of a sensor, indicates that a significant

Figure 11: Typical appearances of the sensor surface before (A) and after (B) removing the loose deposits after a short-term service in the cooling water system. Maximum thickness of the loose deposits was approximately 3 mm.

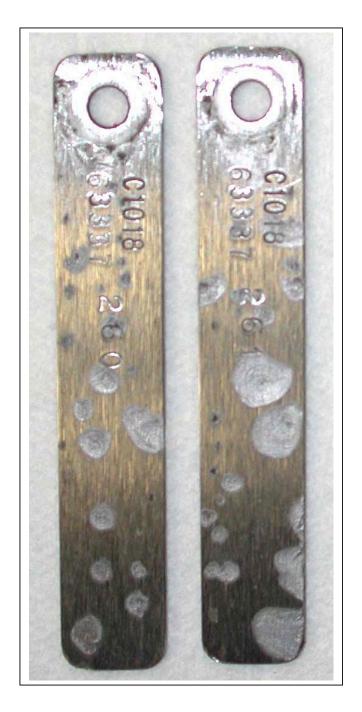
Corrosion coupons were also exposed on a monthly basis. The overall corrosion rates that were calculated on the basis of weight loss showed rates that were in the range of 15-30 mpy over this time period, with an average rate of about 20 mpy. However, it should be noted that these corrosion rates are actually misleading because they did not truly reflect the rate of non-uniform under deposit corrosion that was actually occurring under the deposits that consistently built up on the samples as was shown in Figure 7. Figure 13 illustrates the degree of non-uniform corrosion on a cleaned corrosion coupon. Note that the areas outside of the under-deposit corroded locations still show the machining lines of the coupons from fabrication suggesting that once under-deposit corrosion initiated, corrosion propagated rapidly in these areas. Infact, measurements of depth of attack in these under-deposit corroded areas showed depths of attack that were 5-10X of the general corrosion rates, which translates to localized under-deposit corrosion rates of 100-200 mpy.

It is interesting to note that the "under-deposit" corrosion rates of 100-200 mpy were consistent with the average penetration rates of 100-150 mpy that were measured by the MAS probe. In addition, the areas outside the corroded areas of the coupons were relatively unattacked which was manifested in the MAS probes where a number of the electrodes were unattacked, and others were significantly attacked. This suggests that the design of the MAS probe with small and independent electrodes on the surface can truly simulate the non-uniform and random incidences of underdeposit corrosion on the coupons.

Figure 13: Field Corrosion Coupons after 1-month exposure in plant water. (Note that the areas outside of the under-deposit corroded locations still show the machining lines of the coupons from fabrication suggesting that once under-deposit corrosion initiated, corrosion propagated rapidly in these areas)
