Paper No. 04077

COOLING WATER MONITORING USING COUPLED MULTIELECTRODE ARRAY SENSORS AND OTHER ON-LINE TOOLS

Michael H. Dorsey DuPont Engineering Technology Orange, Texas 77630, USA

Lietai Yang and Narasi Sridhar Southwest Research Institute San Antonio, TX 78238–5166, USA

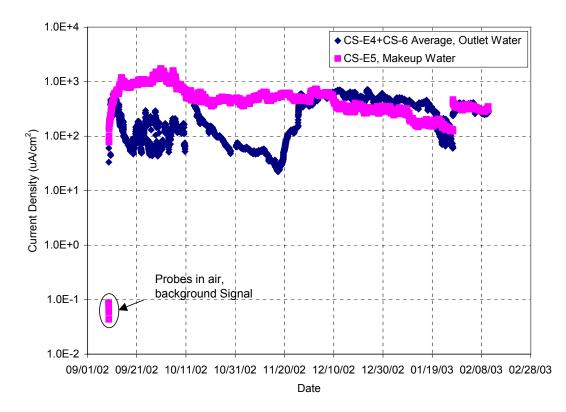
of a three times standard deviation signal is a way to estimate the most anodic current density based on a statistical approach and, thus, is considered more reliable³. Figures 3 and 4 show that the two signals are close to each other and they can be used interchangeably as the corrosion signal of the sensors under the testing conditions.

Figure 3: Localized corrosion signals as represented by three times standard deviation of current densities from the different electrodes of the sensors in the two loops.

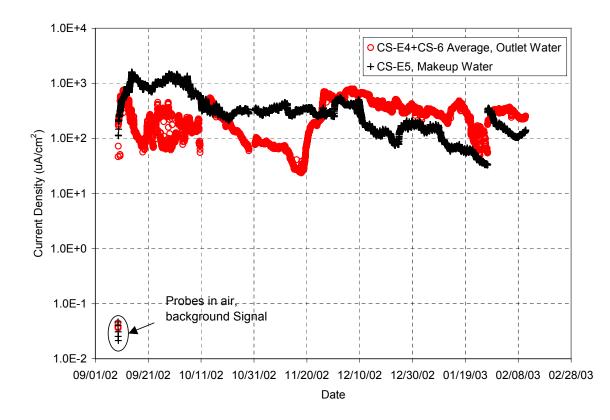
Figure 4: Localized corrosion signals as represented by the maximum anodic current densities from the different electrodes of the sensors in the two loops.

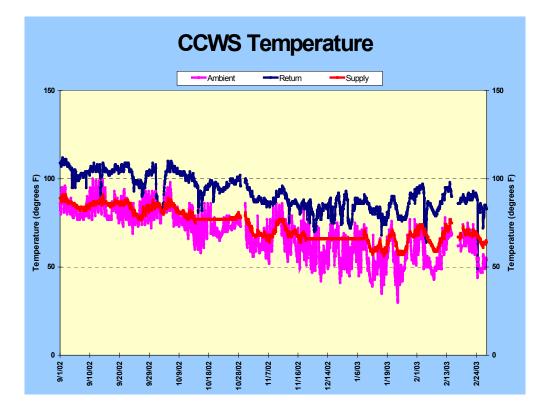
Figure 6 also shows the signals from the outlet water at the beginning and at the end of the monitoring period are essentially the same, indicating that the sensor worked well

Figure 6: Temperature of the Make-Up Water – "Supply" represents the inlet or "make-up" water, and "Return" represents the outlet water.

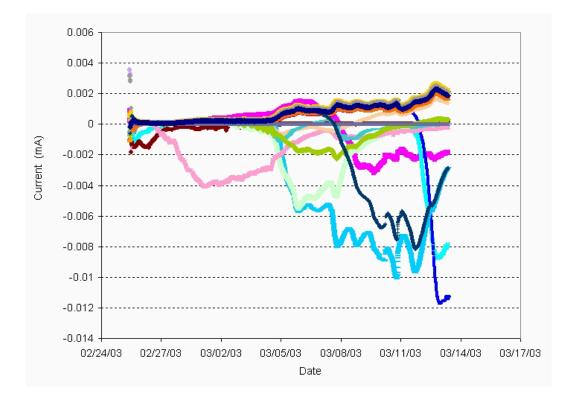
Figure 11 shows typical post-test appearances of the sensor before and after removing the loose deposits. The electrodes under the deposits were severely corroded and the electrodes not covered by the deposits were not corroded after the 16-day exposure in the cooling water system. This large difference in degree of attack is typical of microbiologically influenced corrosion⁴. The corroded electrodes were likely the anodes and the unattacked electrodes were more likely the cathodes. Figure 12, which shows typical currents from each electrode of a sensor, indicates that a significant

Figure 12: Typical currents from the different sensing electrodes in a coupled multielectrode array sensor in the cooling water system during the monitoring period as shown in Figure 10. Note: The currents were from sensor CS-F5 in the makeun water
